# *Final Report*

## **Deflecting the Wave: Using Coastal Vegetation to Mitigate Tsunami and Storm Surge**

Tropical Landscape and Human Interaction Lab  
Department of Tropical Plant and Soil Sciences  
College of Tropical Agriculture and Human Resources  
University of Hawai‘i at Mānoa

**June 2015**

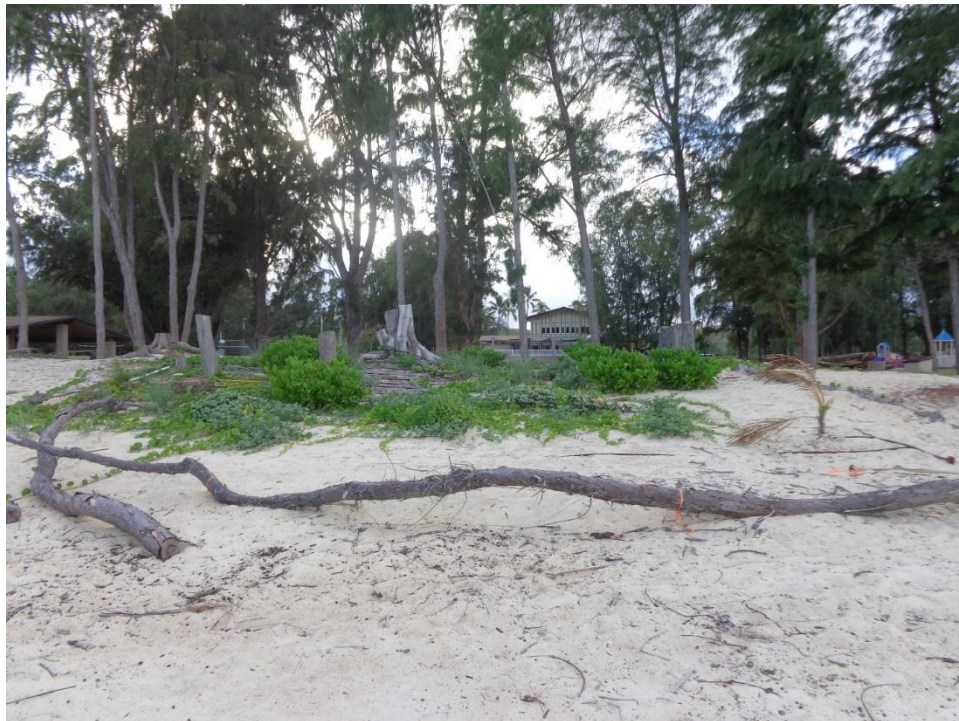
Figure 112. Plots with and without screen, foredune, panoramic view from east, 5 months after planting (9/17/2014).

The plot with screen had a clearly advantage in the first months after installation, covering the soil faster than the plot with no screen (Figures 97 to 112). However, the plot without screen eventually catch up and started to look similar about 6 to 10 months after planting (Figures 113-116). Finally, the plot without screen looked better than the plot with screen one year after planting (Figures 117-118). These observations will be discussed in the results, conclusions and recommendations sections.

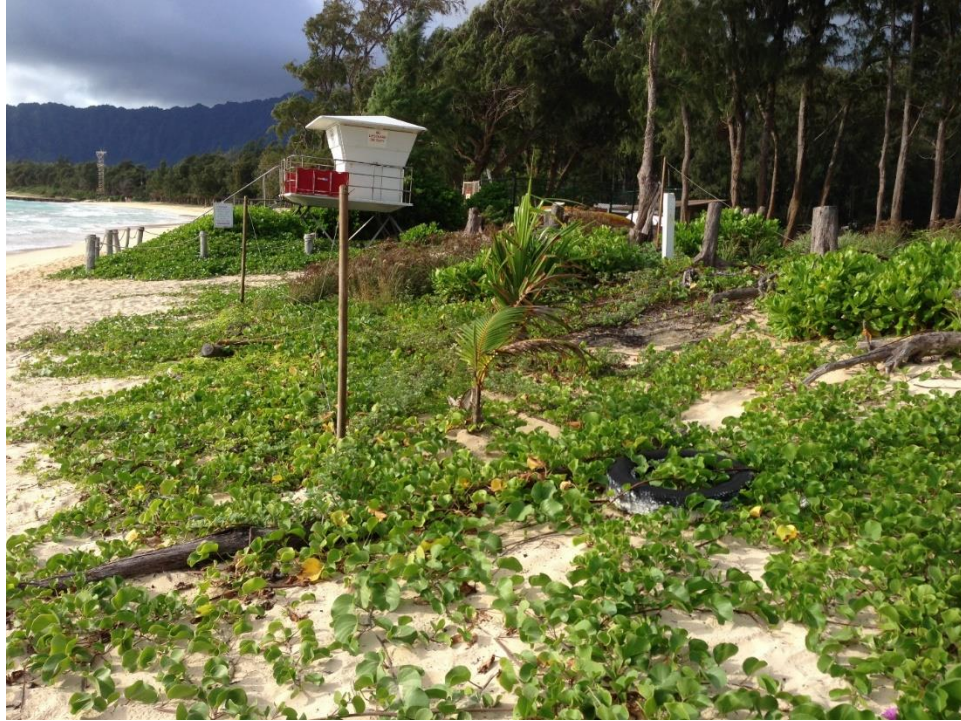
Figure 113. Plot with screen, foredune, view from north, 6 months after planting, 10/27/2014.

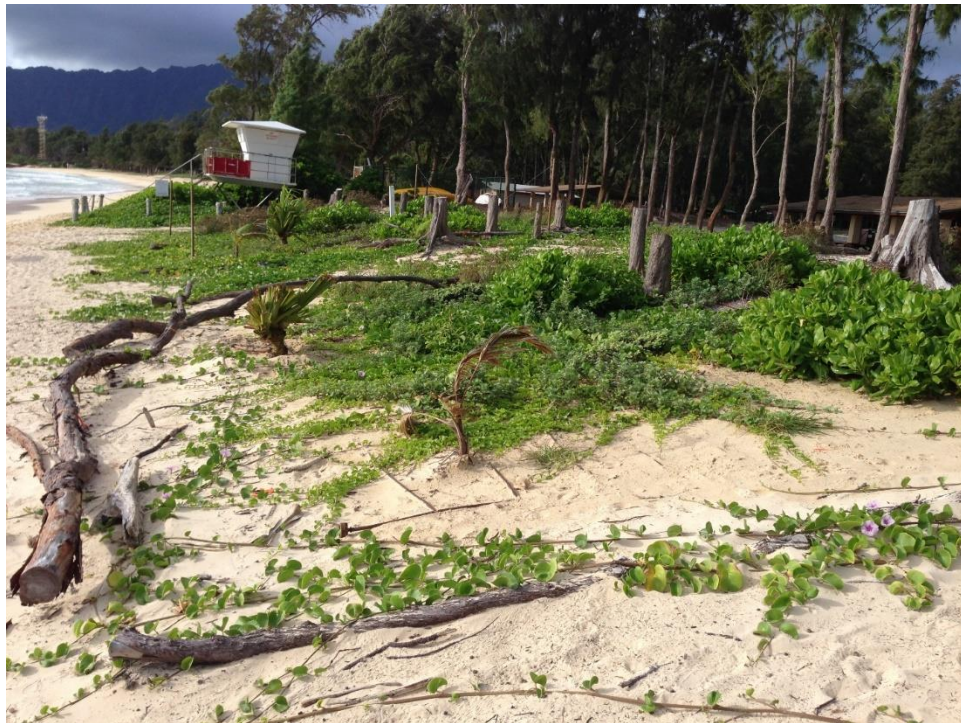
Figure 114. Plot without screen, foredune, view from north, 6 months after planting, 10/27/2014.

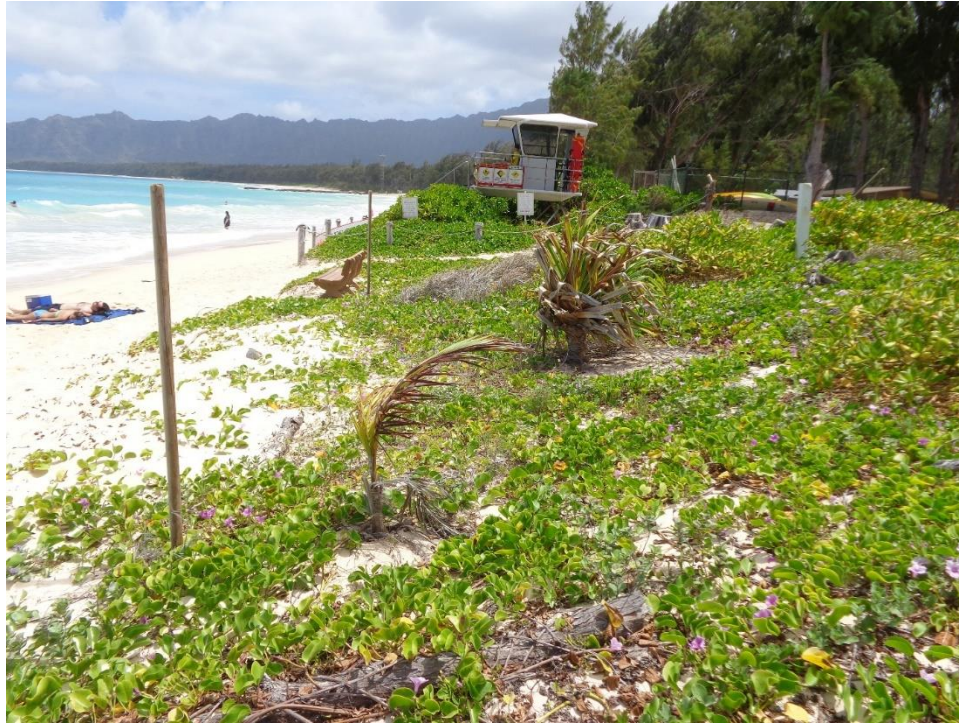
Figure 117. Plot with screen, foredune, view from north, 13 months after planting, 05/18/2015.

Initially, the plot with screen was clearly more covered by ground covers than the plot with no screen (Figures 102-103). However, thirteen months after planting, the plot with no screen had higher ground coverage when compared to the plot that had wind screen in the first three months after planting (Table 19, Figures 117 and 118). This result corroborates with the height of ground covers.

Plants growing with screens were protected from the wind and the sand was moister than the plot with no screen, which probably resulted in plants with shallower root system compared to the plants growing without screen that had to seek deeper for water. Simultaneously, the plot with no screen experienced more deposit of sand, because the screen did not pose a barrier and the plot with no screen was more exposed to the wind, which comes from the NE direction. Therefore, sand accumulated more in the plot with no screen, which covered the irrigation system, making it deeper, resulting in less loss of water through evaporation. When the screen was removed, the plants from the plot with no screen were likely to be more adapted to the wind and salt spray, and with deeper root system and deeper irrigation dripline, and more able to overcome stresses from the elements. This could explain the better results of plants growing in the plot without screen, thirteen months after planting.

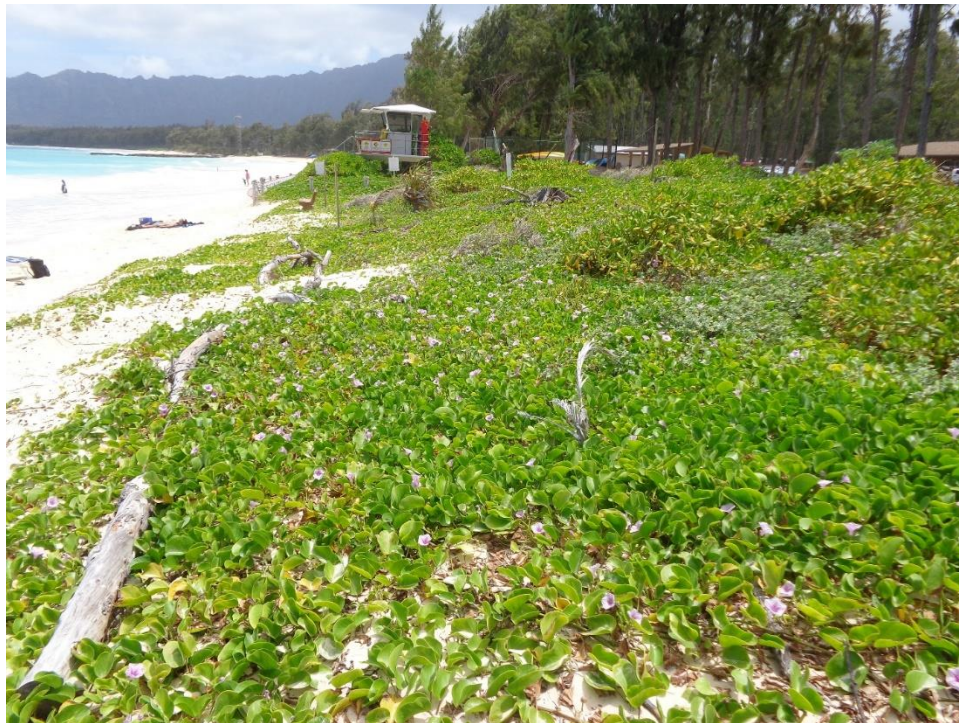
Figure 118. Plot without screen, foredune, view from north, 13 months after planting, 05/18/2015.

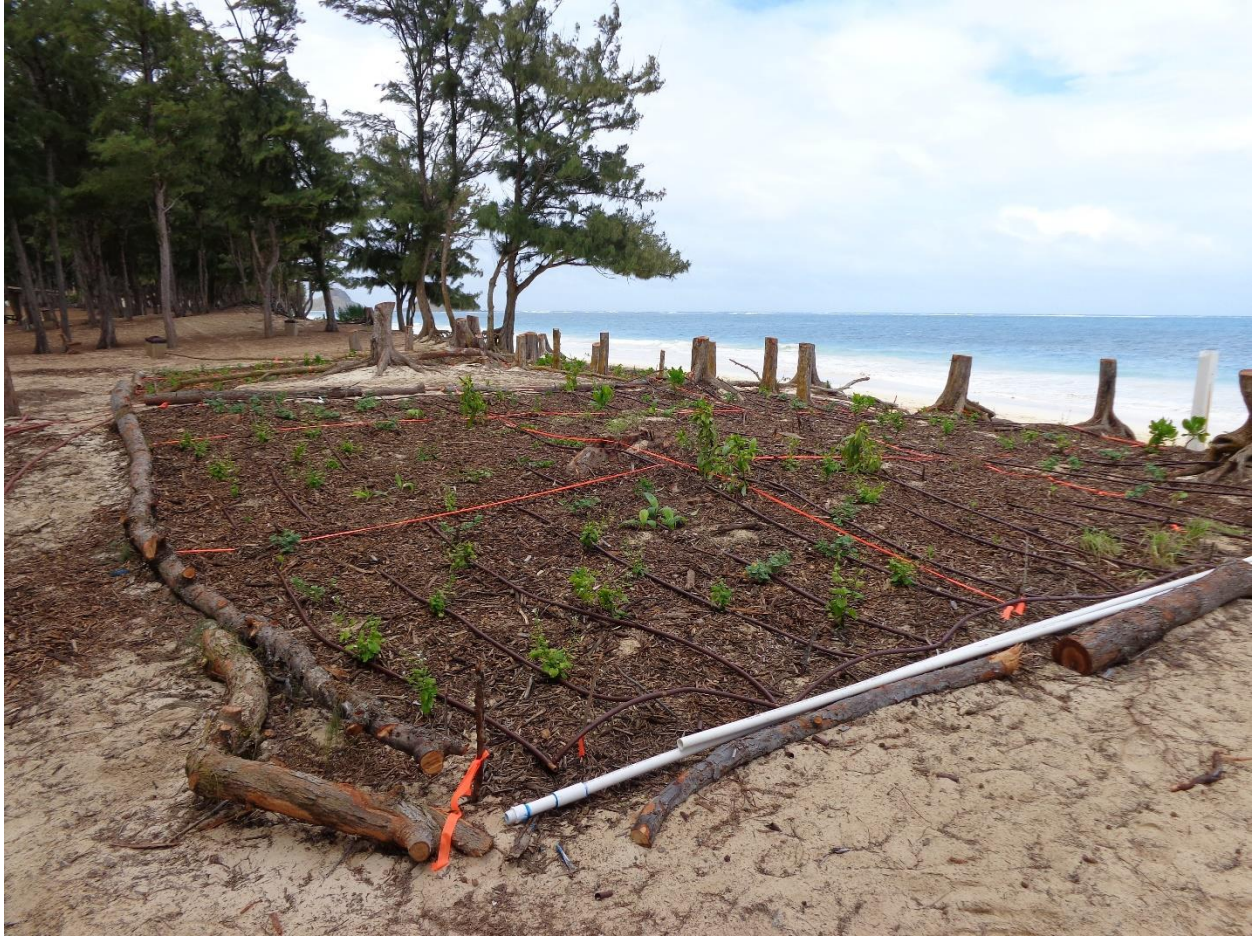
Figure 120. Plot market with orange tree-tapes, used to guide planting and evaluations.

Plant population was determined by dividing the plot in 15 subplots, forming a grid (figures 119 and 120). Field notes were taken using the table shown in figure 121.

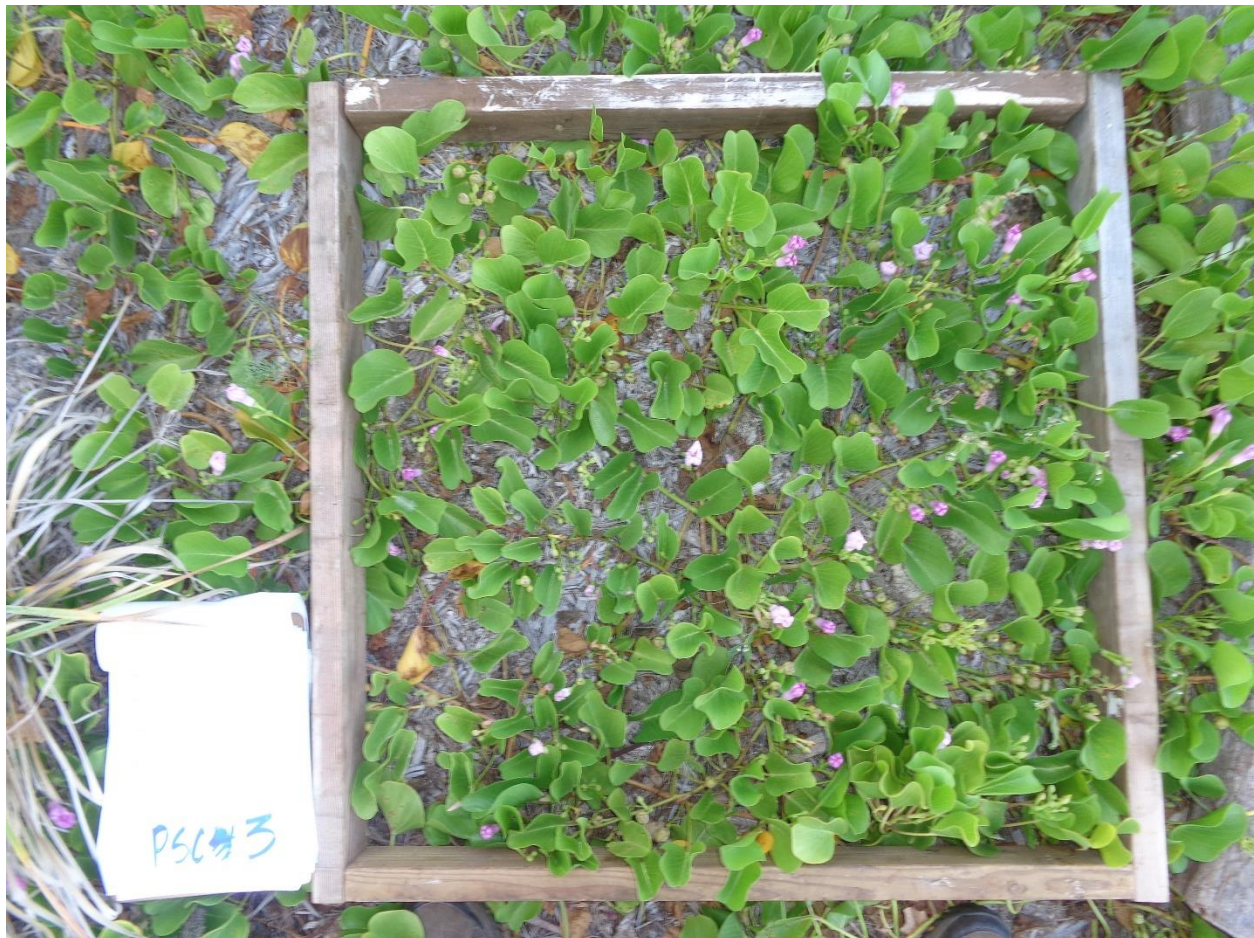
Figure 122. Wood frame measuring 3ft by 3ft, used to take pictures for coverage analysis and to collect samples for dry weight.

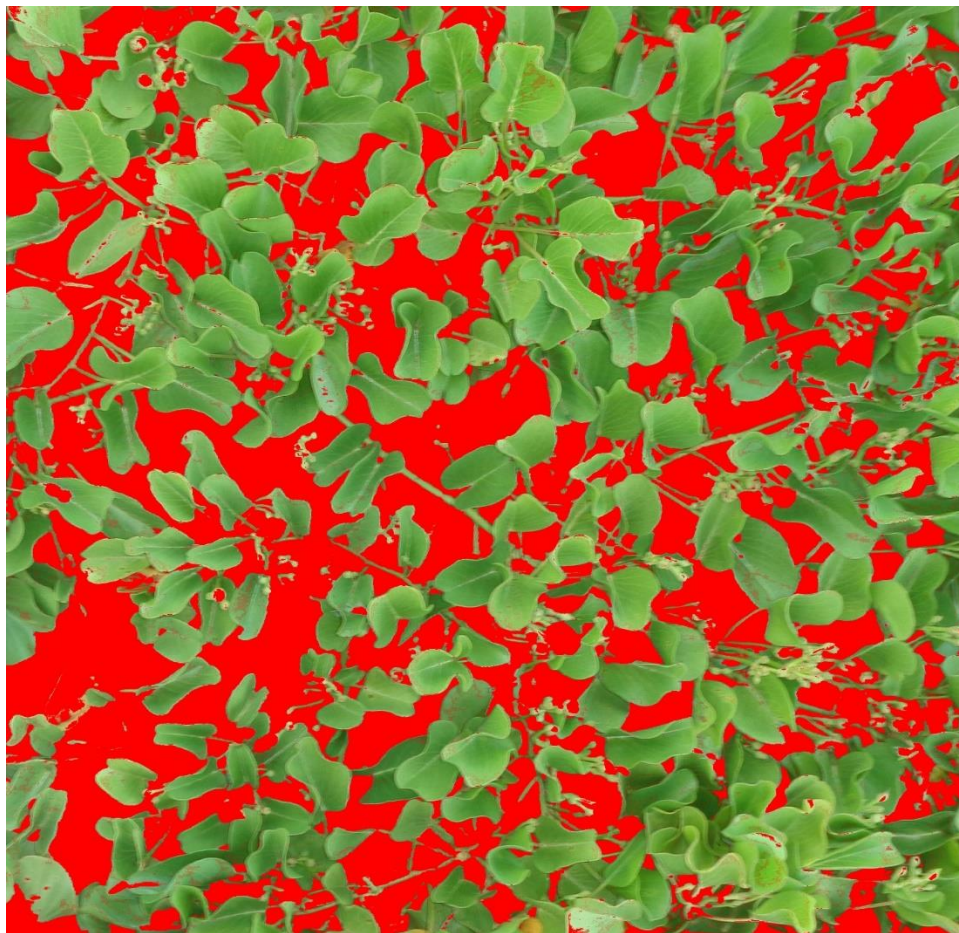
Figure 123. Image cropped and manipulated to calculate the ground coverage by green plants.

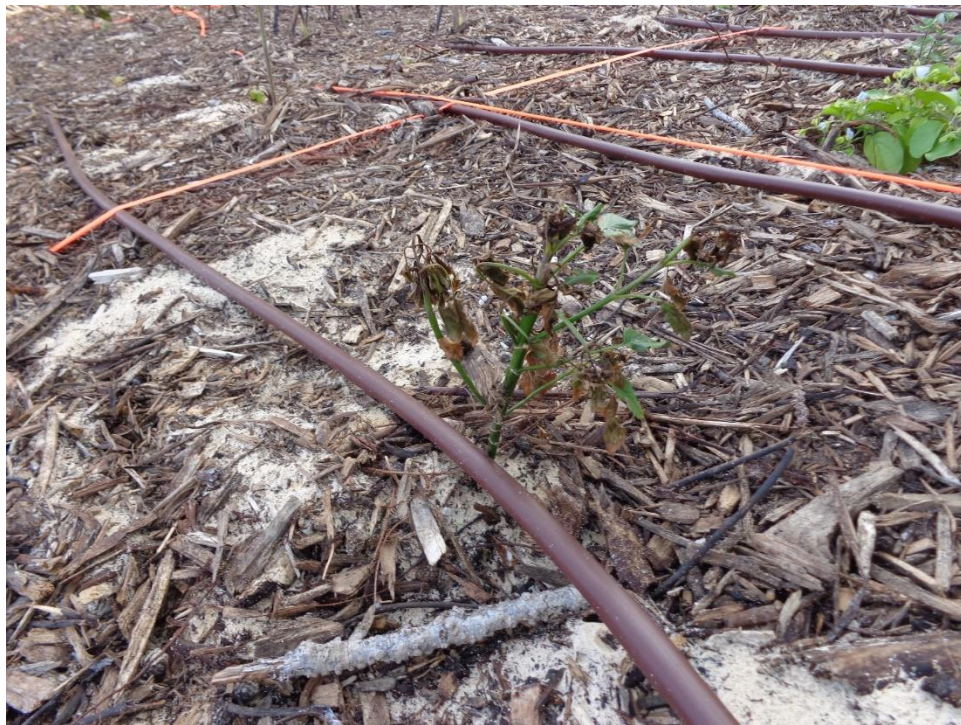
Figure 127. Bidens 4 days after planting (04/23/2014).

Ko'oko'olau is not recommended to be planted in bare beaches, without protection of other plants or structures. All plants (two per plot, total 8 plants) dried out within two weeks after planting (Figures 126 to 128). It seemed to don't tolerate salt spray, therefore, it could be planted in the back dune after other plants have established, protected from wind and salt spray, instead of planting at the beginning of the dune restoration. Therefore, future restoration projects should consider staged planting.

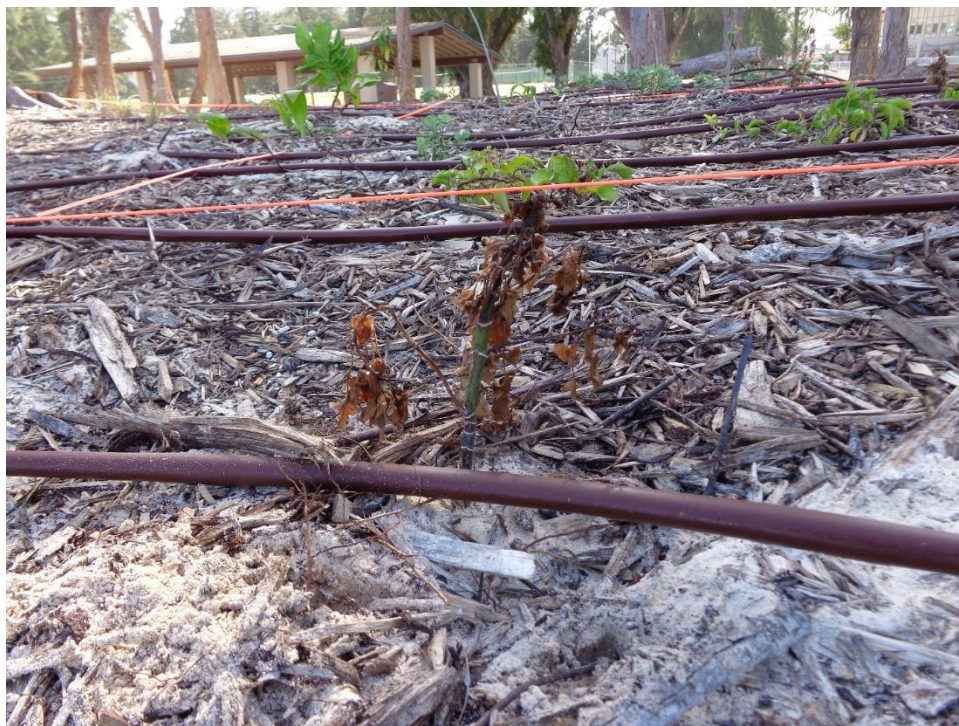
Figure 128. Bidens 15 days after planting (05/05/2014)

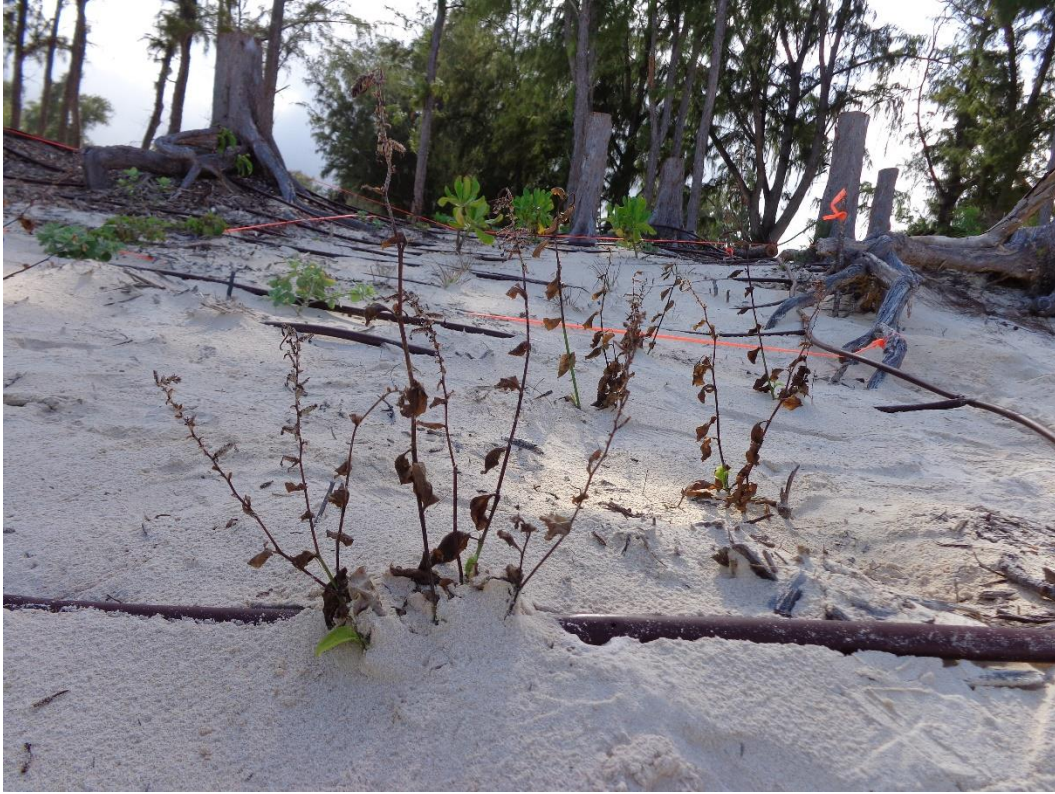
Figure 130. 'Ilie'e in the foredune, 2 weeks after plangin, very sensitive to salt spray.

The Hawaiian plumbago survived only in the back-dune zone, however, it was struggling after the irrigation was removed, with yellow leaves and dry appearance (129 to 132), and were eventually dominated by *Ipomoea* and *Vitex*. It might not be a plant suitable for dune restoration, with low salt tolerance, but should be considered for areas not exposed to salt spray.

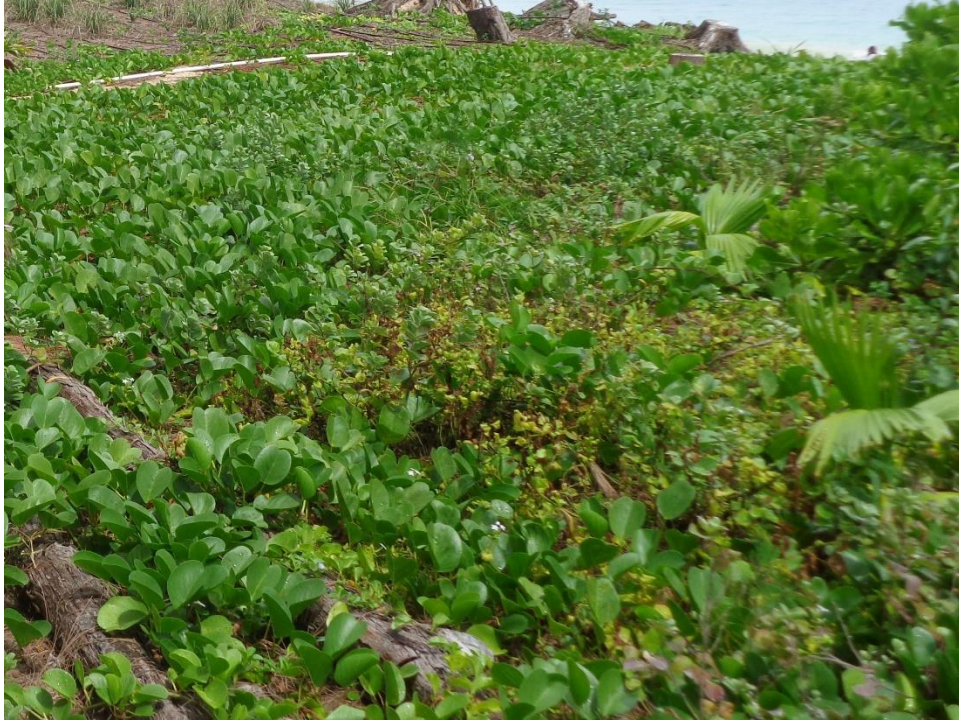
Figure 132. 'Ilie'e 10 months after planting, starting to turn yellow.

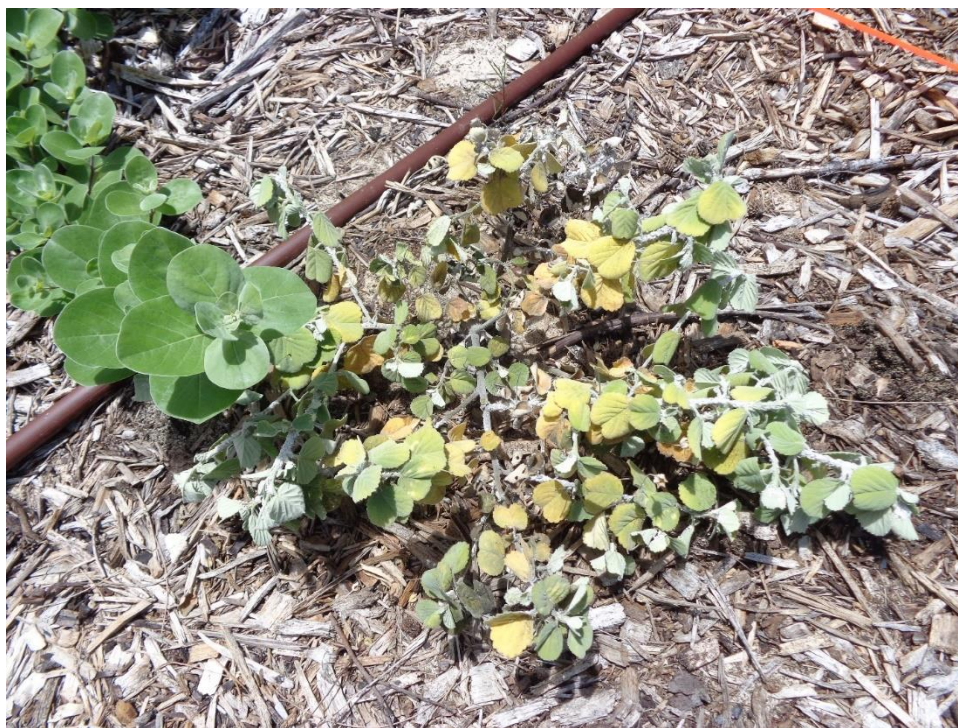
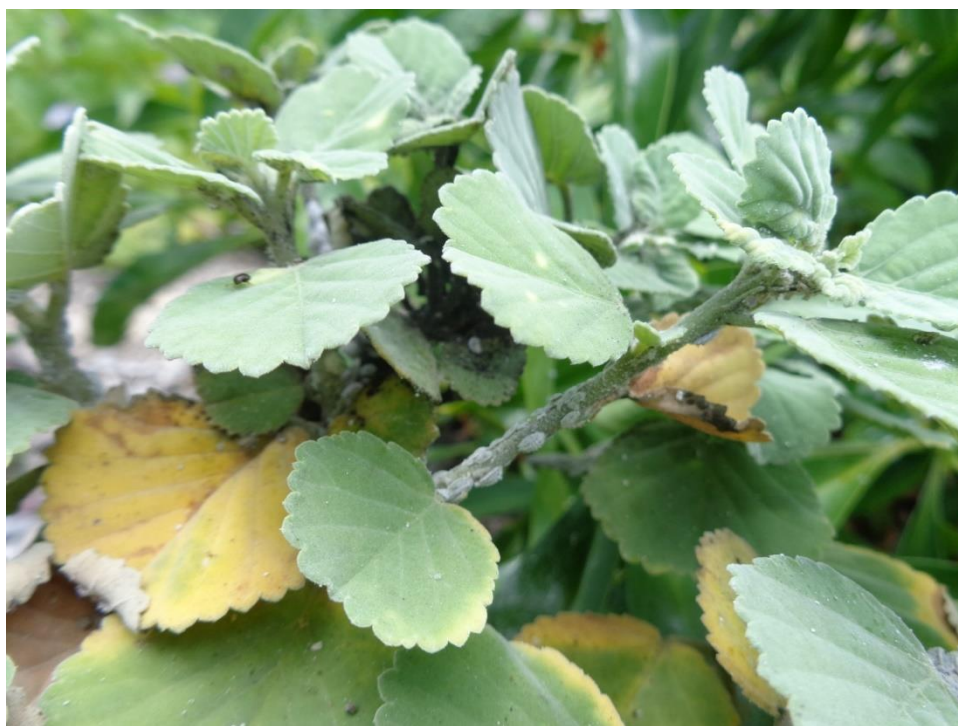
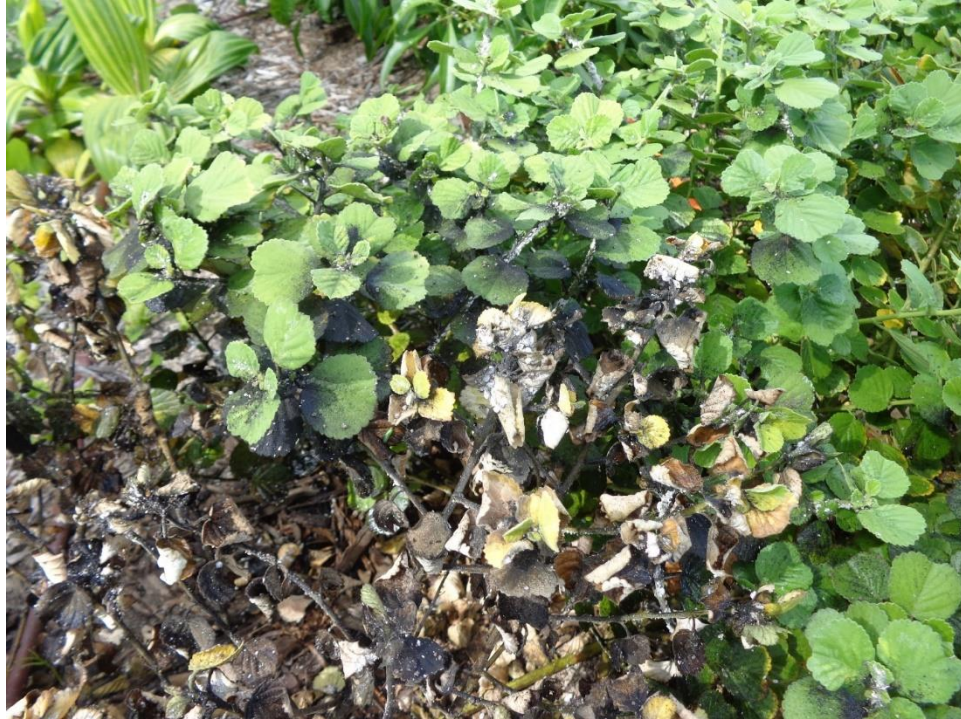
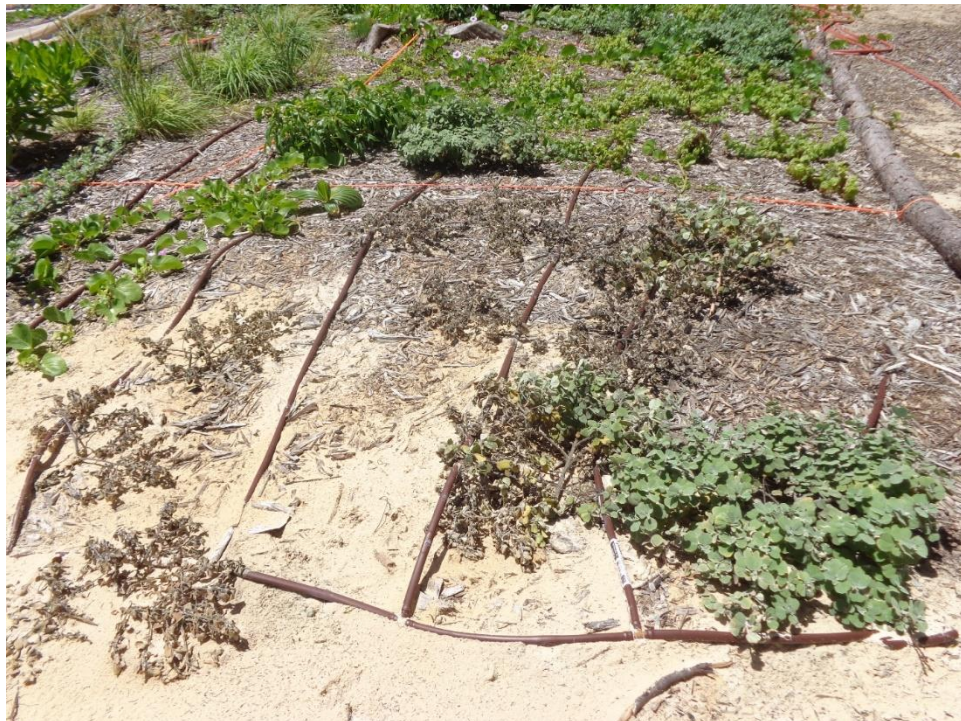
Figure 136. Ilima 2.5 months after planting, attacked by mealy bugs.

Figure 137. Ilima 2.5 months after planting, attacked by mealy bugs.

Figure 138. Ilima 2.5 months after planting, attacked by mealy bugs.

Figure 139. Ilima 2.5 months after planting, attacked by mealy bugs.

However, the plant supplier provided a different cultivar, with round leaves (Figure 134 and 135), instead of the typical narrow leaf ilima found at Bellows. The plants did not show signs of stress from wind and salt, however, were infested with mealy bugs (Figures 136 to 139), which were controlled with organic pesticides only after most of the plants were killed. The plants that survived were up to 36" wide by 16 inches high at 3 months after planting, and 3 ft wide by 2 ft high 13 months after planted (Figure 140).

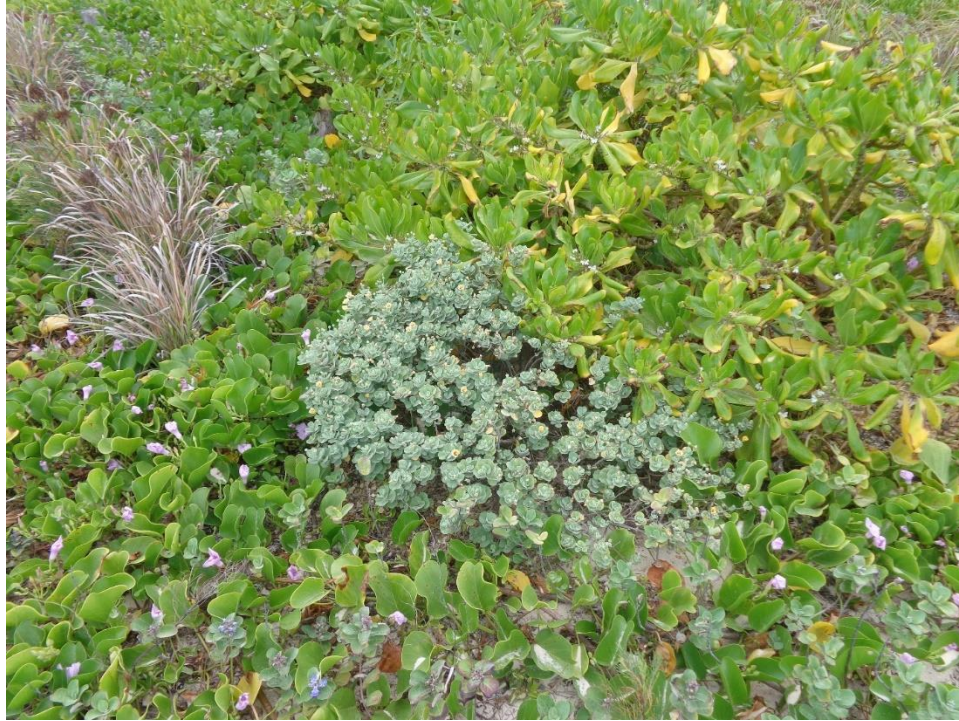
Figure 140. Broad leaf Ilima that survived from initial planting, thirteen months after planted.

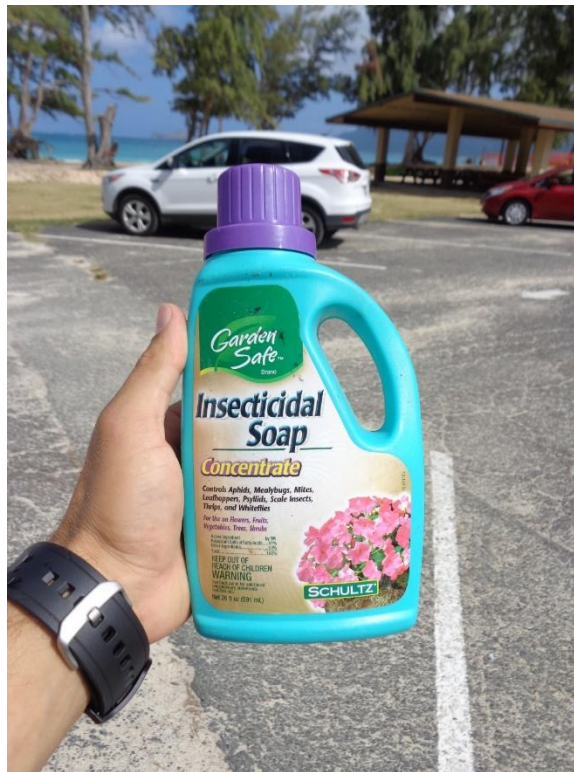
Figure 141. Insecticidal soap, which didn't work for mealy bug control.

Insecticidal soup was not efficient on the control of the mealy bugs, even after three application (Figure 141). The “EcoSMART Organic Insecticide”, however, controlled the mealybugs after liquid and granular application (Figures 142). The insecticide also burned some plants where the insecticide was applied.

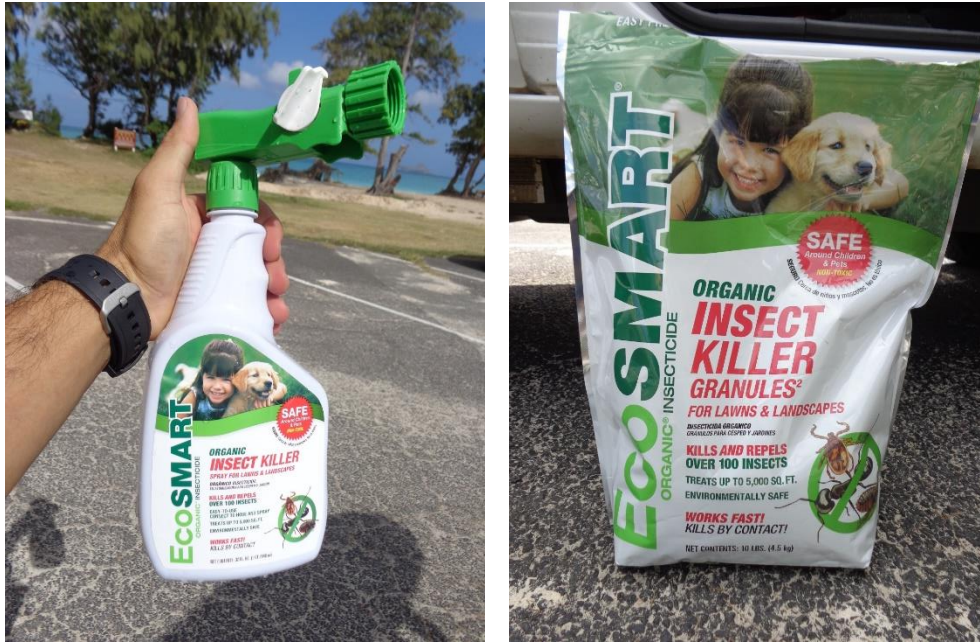
Figure 142. EcoSMART Organic Insecticide, which helped to control mealybug.

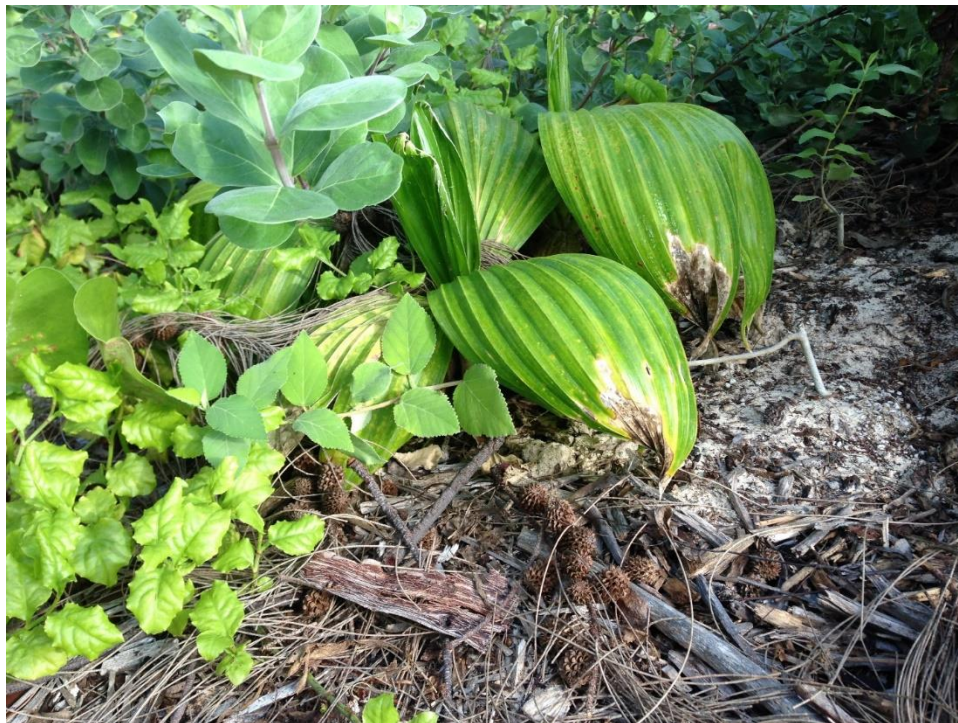
Figure 143. Ilima propagated in the nursery from planting growing at Bellows and transplanted to the experimental plots (10/28/2014)

Narrow leaf ilima was propagated and successfully transplanted into the plots after the mealy bug population as controlled (Figures 143 and 144).

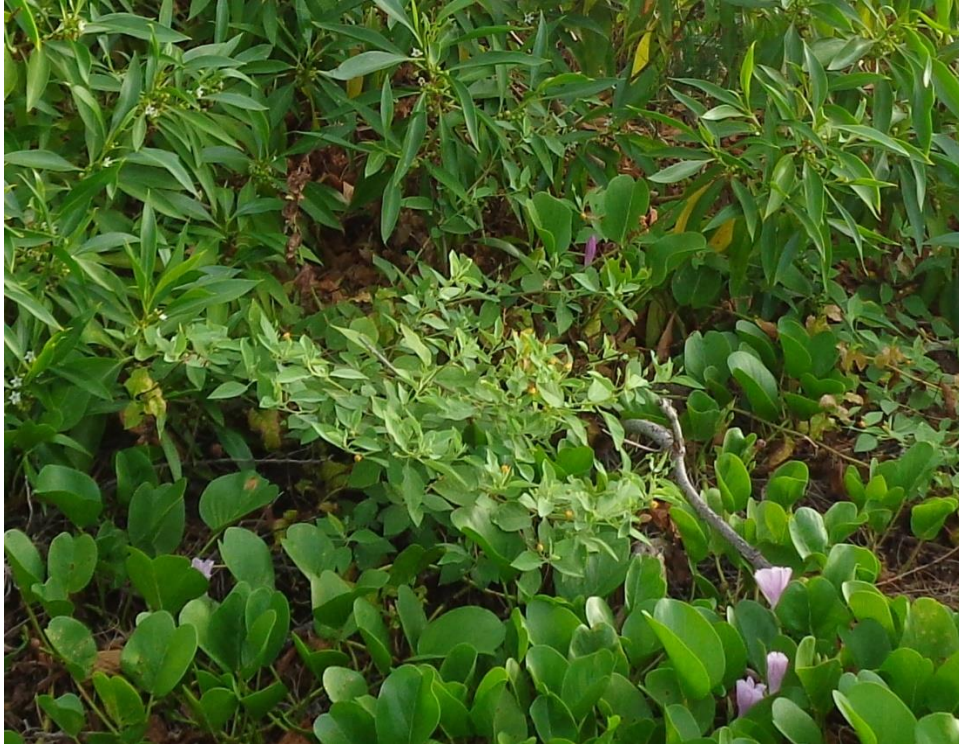
Figure 144. Ilima propagated at Bellows, 6 months after transplant (05/01/2015).

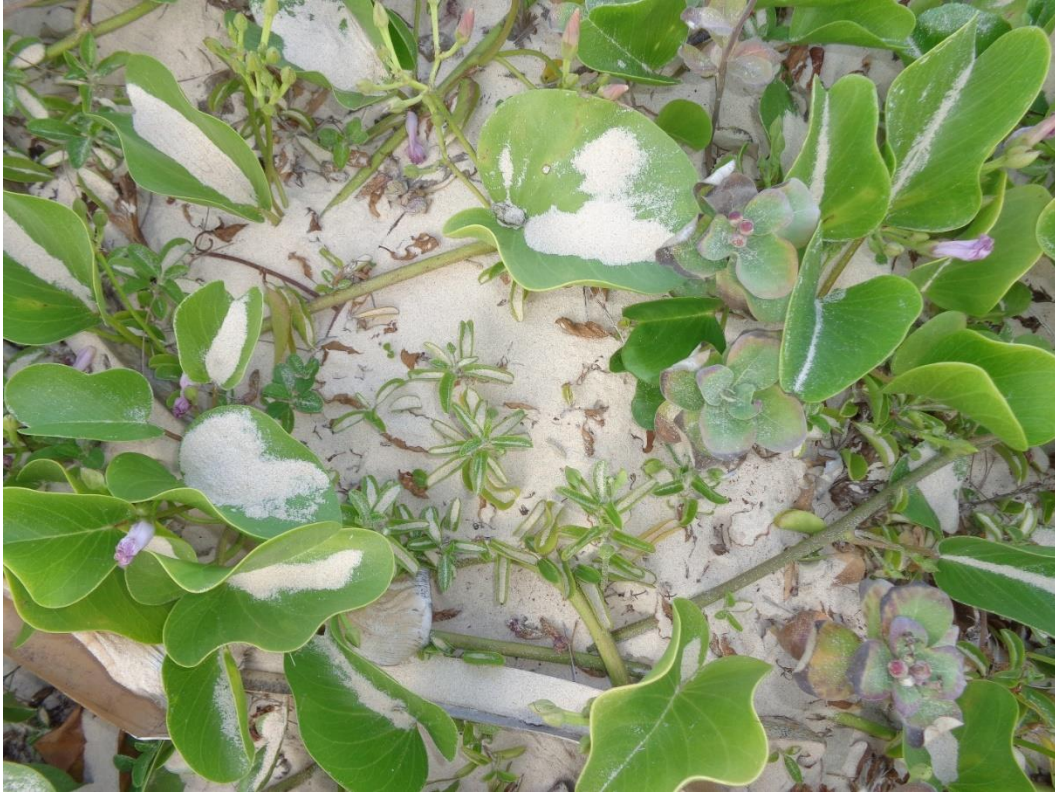
Figure 149. Sand trapped by *Ipomoea pes-caprae* subsp. *brasiliensis* and *Jacquemontia sandwicensis* ground on the beach side of the plot.

Pōhuehue, or beach morning glory, was the most effective ground cover in this trial. It was also documented by Jayatissa and Hettiarachi 2006 as one of the species not unaffected in inundated areas of Sri Lanka following the 2004 Indian Ocean tsunami. Pōhuehue successfully covered the entire plot and grew up to 14 inches beyond the planted area (Figure 149 to 161). The leaves were larger and taller in the back dune than in the fore dune (Table 14), however, the plant was uniformly distributed along the dune profile (Figure 148). *Ipomoea pes-caprae* is an excellent ground cover to trap sand, as shown in Figure 149. It allowed other groundcovers such as pohinahina and naio papa to grow in the same area. Pōhuehue grew well with ‘aki‘aki grass as well. It was very effective to trap sand, as sand mounds could be seen after wind days, held by Pōhuehue vines and roots.

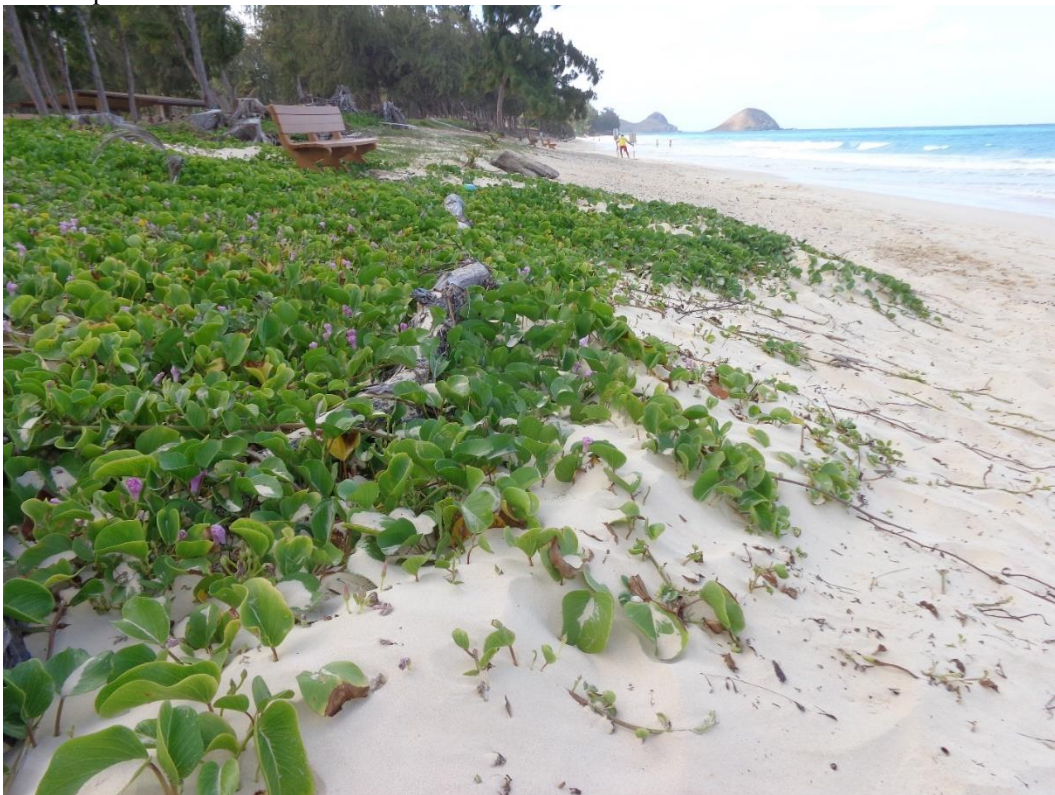
Figure 106. Picture taken 13 months after planting (05/18/2015), showing the advancement of *Ipomoea pes-caprae* subsp. *brasiliensis* beyond the planting area, and clearly helping to trap and hold sand. The dashed line represents a

profile of the sand dune level 13 months after planting, and the dotted lines represents a profile of the beach before planting.

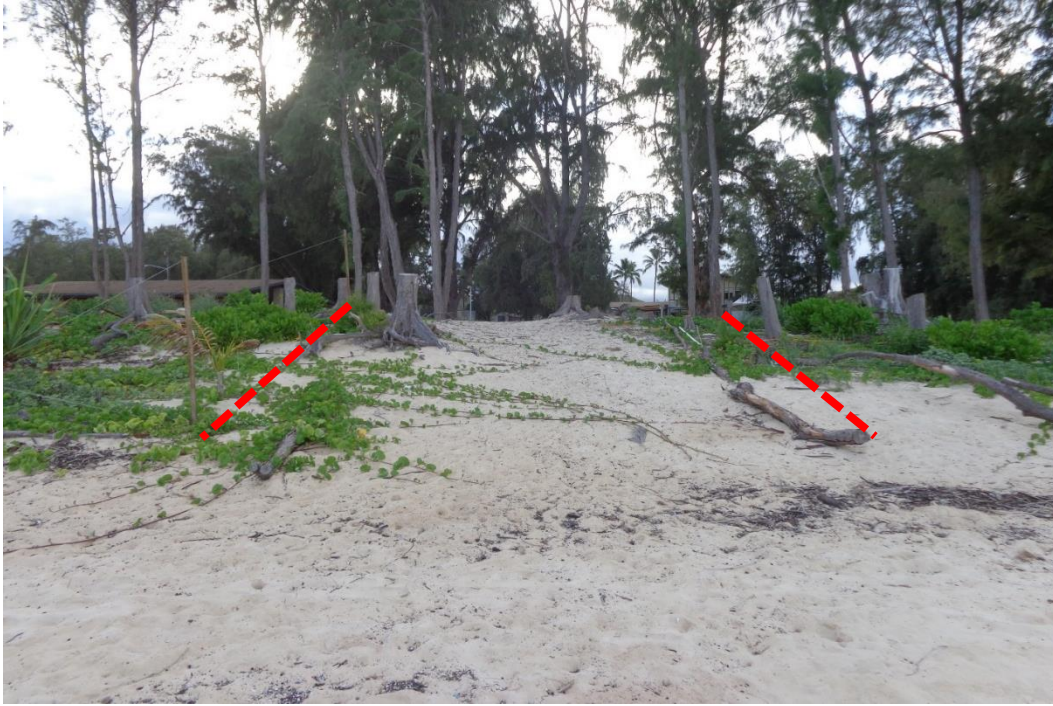
Figure 150. Detail of gap between the two planted plots, identified by the two dashed lines, five months after planting (9/17/2014). Not vine *Ipomoea pes-caprae* subsp. *brasiliensis* starting to grow beyond the plots, from both sides.
